Vehicle Maintenance Access

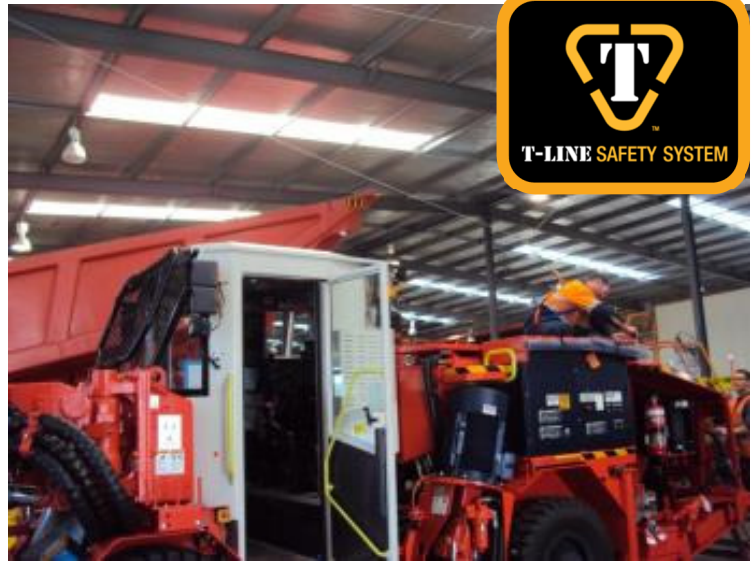
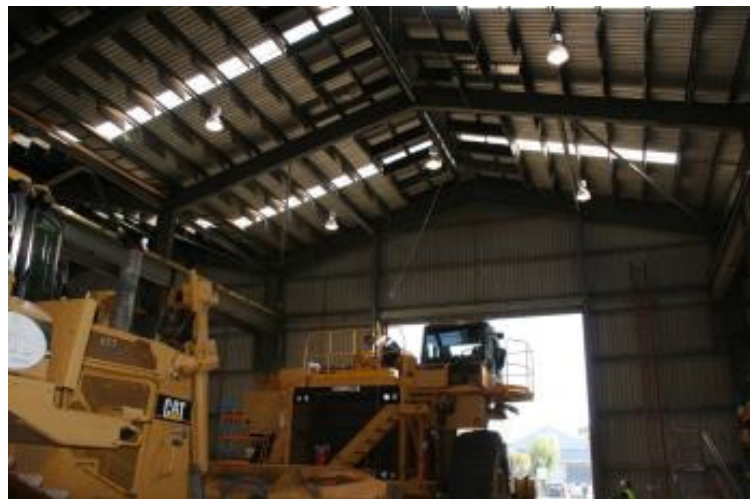
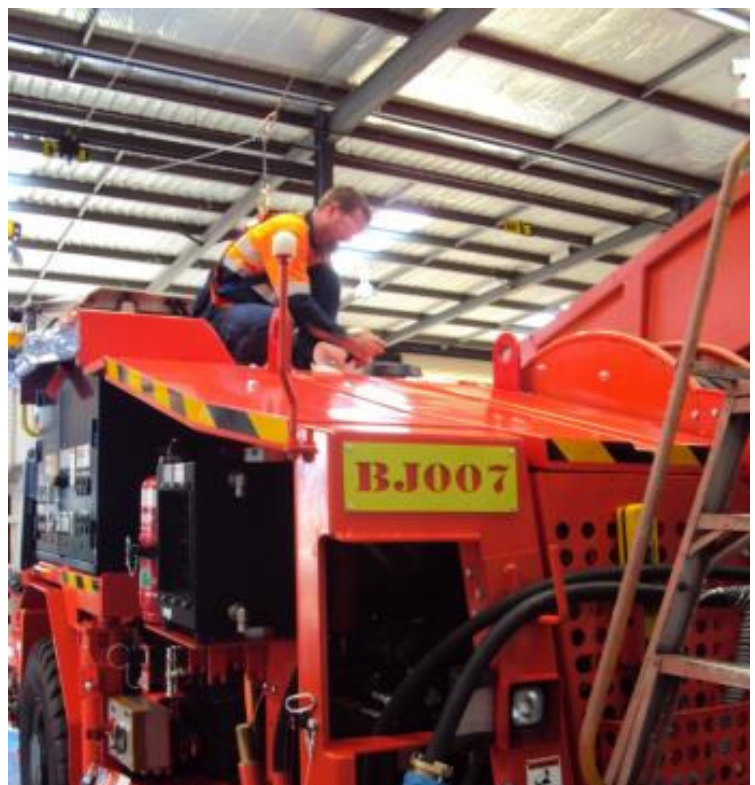
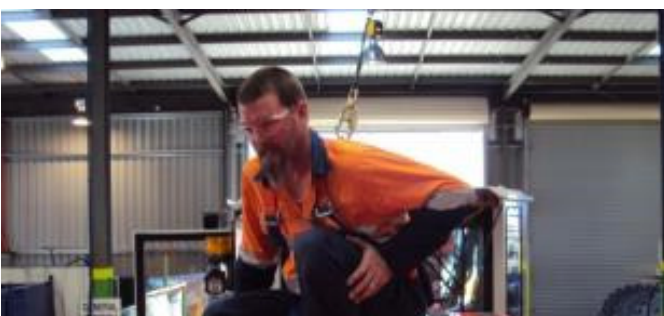
- A 12m T-Line was installed in the work bay.
- This allowed the users to access the full length and width of any piece of equipment from the one system.
- The system was able to be installed on the sloping roof without the need for expensive structural modifications.
- The short fall arrest distances provided by the T-Line were more like those of a rigid rail type system, except at a fraction of the cost.
- This provides superior levels of safety for the users when working in the vicinity of potentially dangerous objects.
